Inspection Report

Minerals Regulatory Program

Mine Name: Myrin Pit
Operator Name: W. W. Clyde

Permit number: M0130010
Inspection Date: October 30, 2006
Time: 3:30-4:00 PM

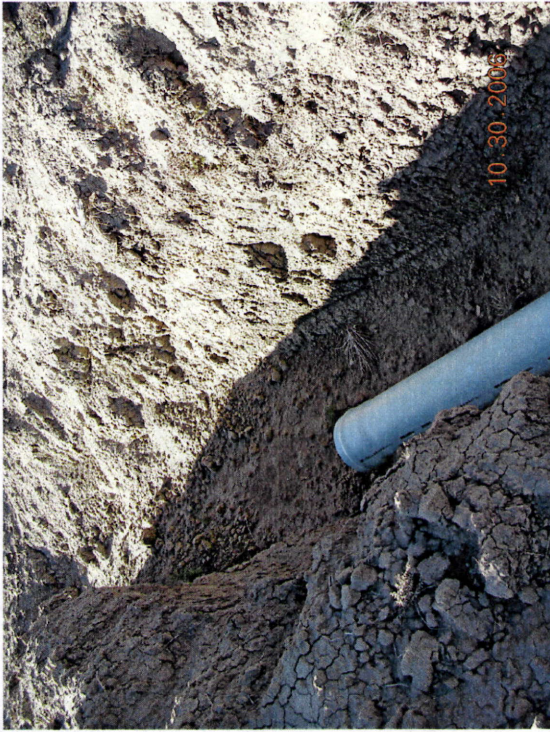
The site has been graded to be an irrigation pond. There is little or no natural flow into the pond, and it does not appear an inlet has yet been installed, such as from an irrigation canal. There does appear to be an outlet system as shown in Photos 1 and 2. These valves are connected to a line of risers that extend to an overhead irrigation line at an adjacent pasture or alfalfa field.

Photo 1. This appears to be an outlet pipe.

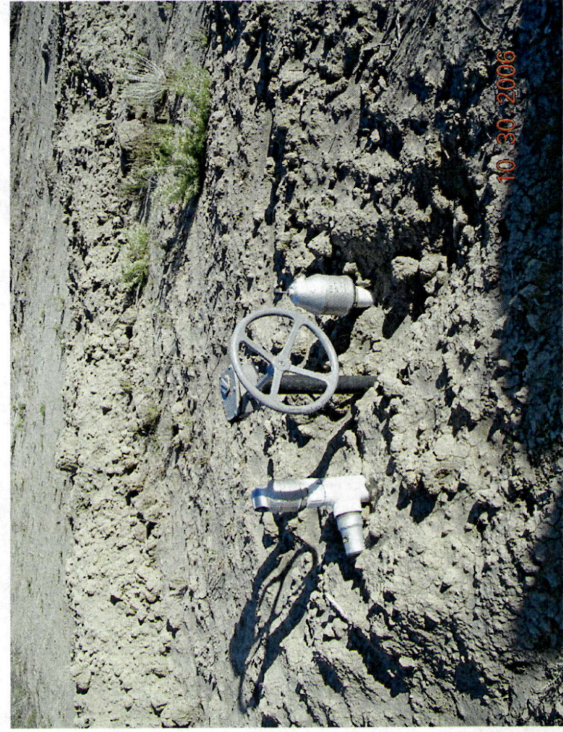
Photo 2. Part of a system of valves near the pipe shown in Photo 1. There is a line of risers extending in two directions from this point.

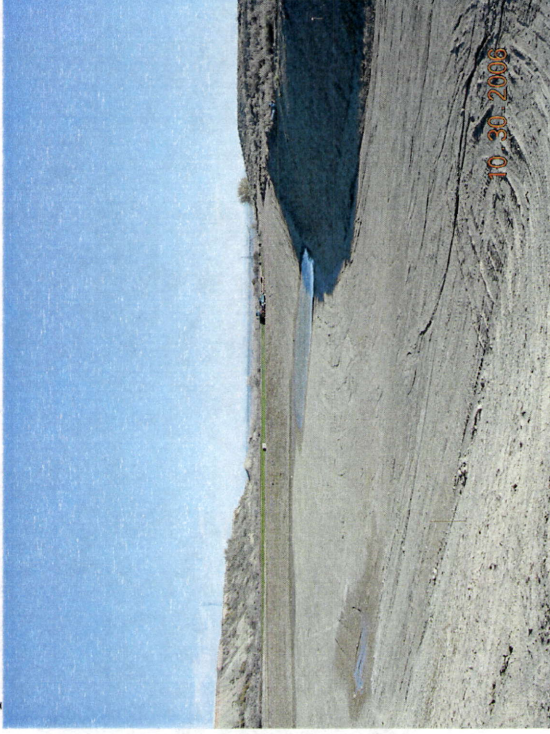
The steepest slopes around the pond are not so steep that an animal or person would not be able to escape under dry conditions. I would be concerned that it might be possible for an animal to get stuck if the soil was saturated.

Photo 3. An overview of the pond.

I will recommend that the site and the surety be released, but the Division may need to have a letter from the land owner agreeing to the land use. The site has been graded to be compatible with the development of a pond.. I recommend that the land owner fence the pond.

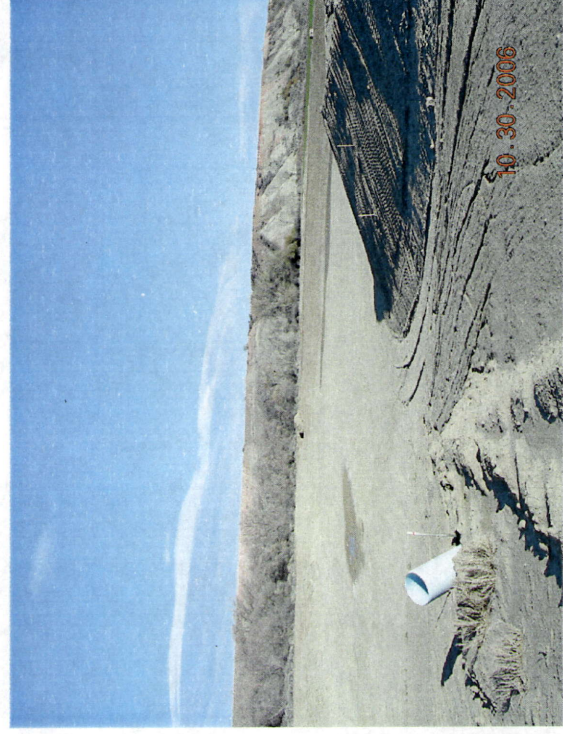
Photo 4. Another view of the pond. The pipe in this photo is non-functional.
